Water Compliance Inspection Report

**NPDES
Compliance Inspection Report**

Pomeroy Farm, LLC

March 31, 2010

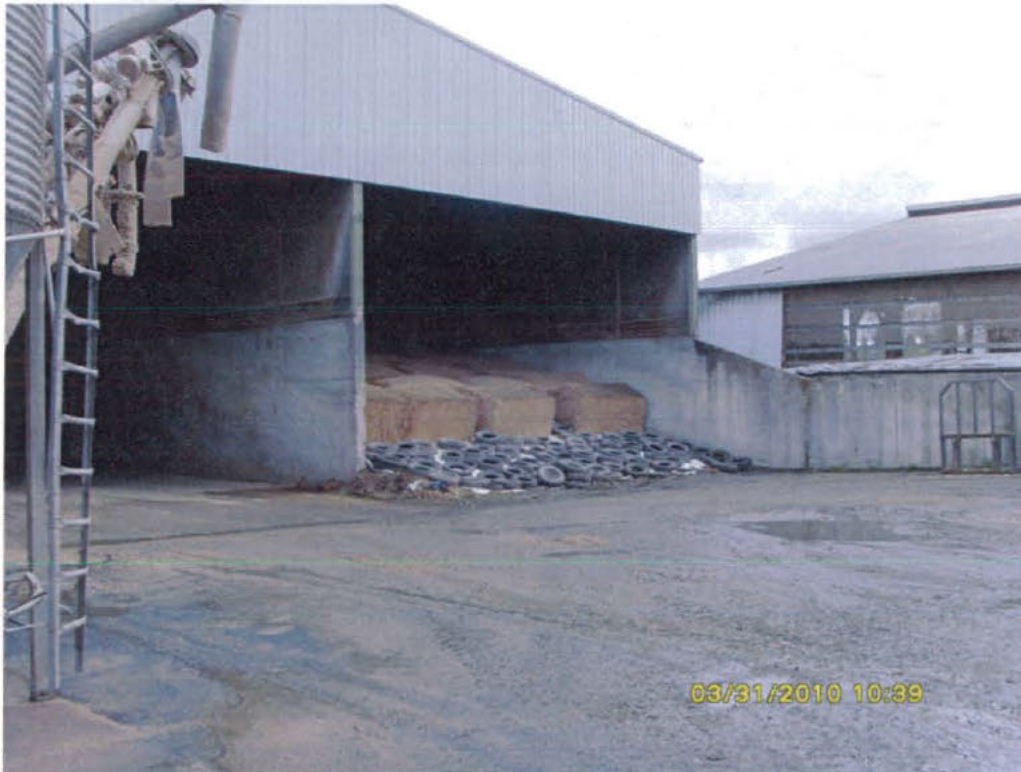
The feed was stored in concrete bunkers and was covered with a roof (photo 1). At the main dairy, there is a drain that pumps any stormwater runoff from the feed storage area into one of the below-ground storage tanks (photo 2).

Photo 1. Feed storage at the main dairy.

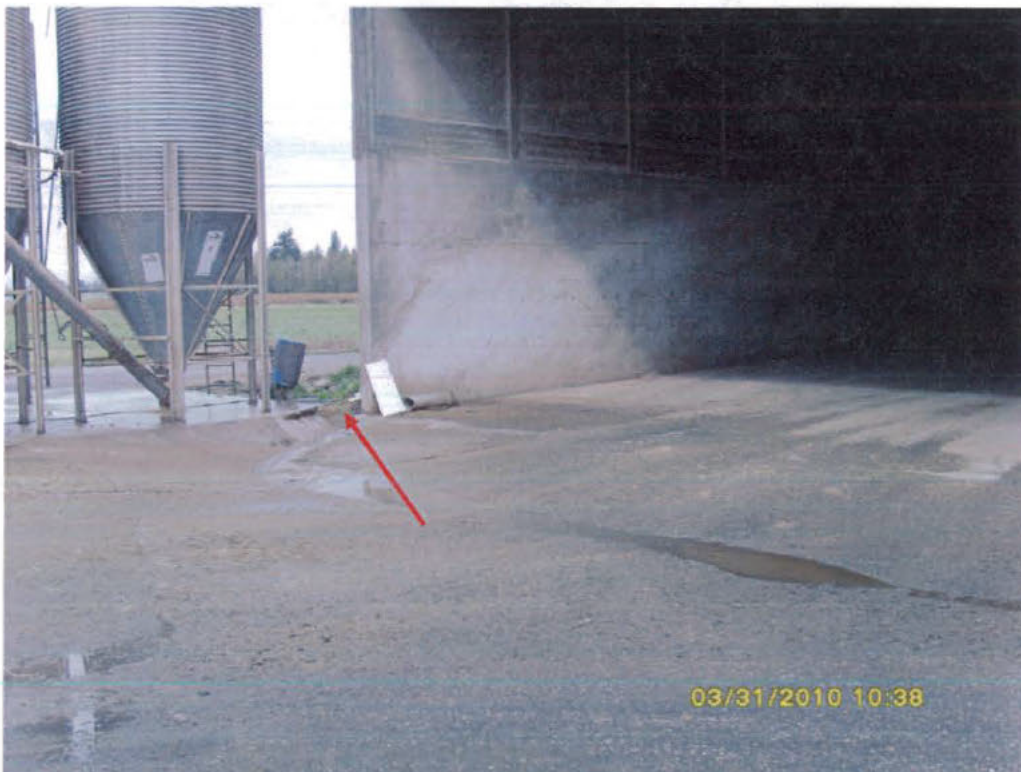
Photo 2. Arrow indicates direction of stormwater flow towards a pump that routes stormwater from the feed storage area into a below-ground storage tank.

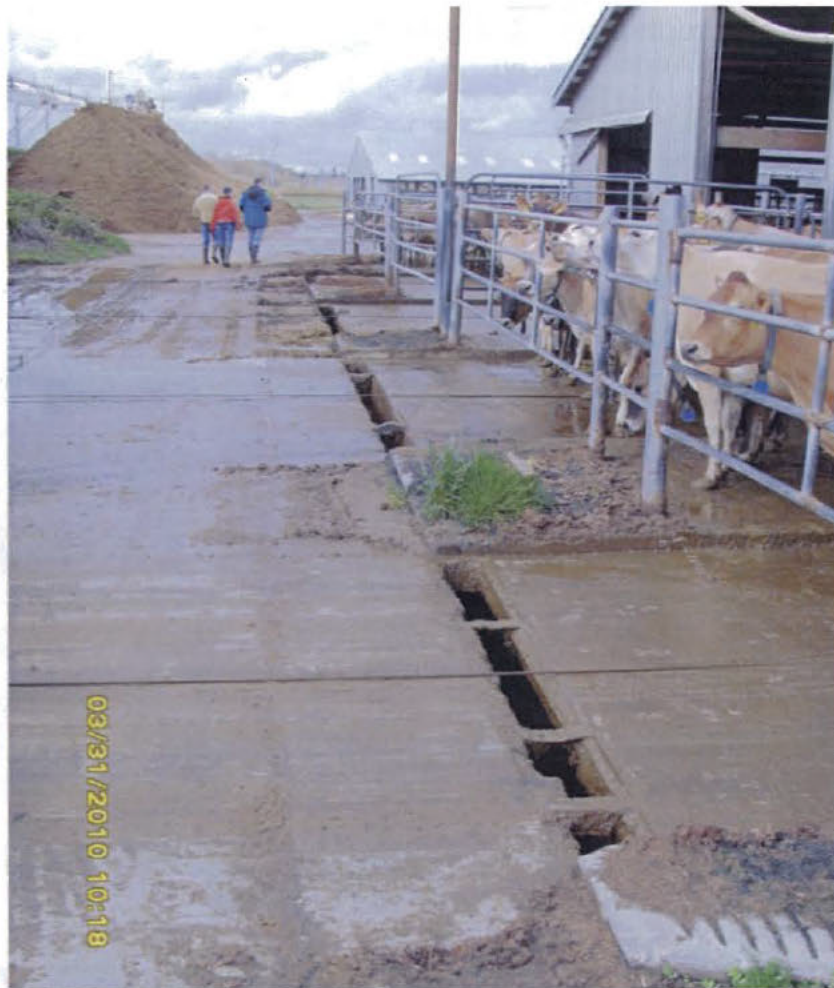
At the main dairy, waste from the barns is scraped using automatic scrapers into pits, which flow through tunnels into one of the below-ground storage tanks. From there, waste is pumped to the solids separator. Liquid waste is routed from the solids separator into the first lagoon (photos 3 – 6). Waste can be pumped between the two lagoons as needed.

Photo 3. Automatic barn scrapers with slot drains at the end of each barn.

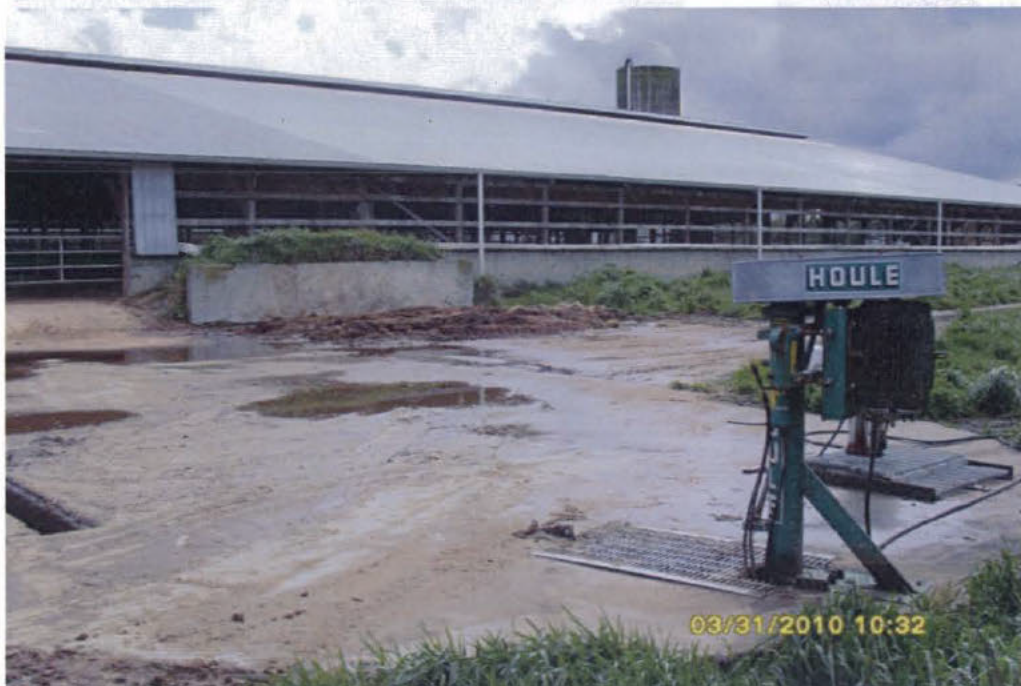
Photo 4. Below-ground storage tank.

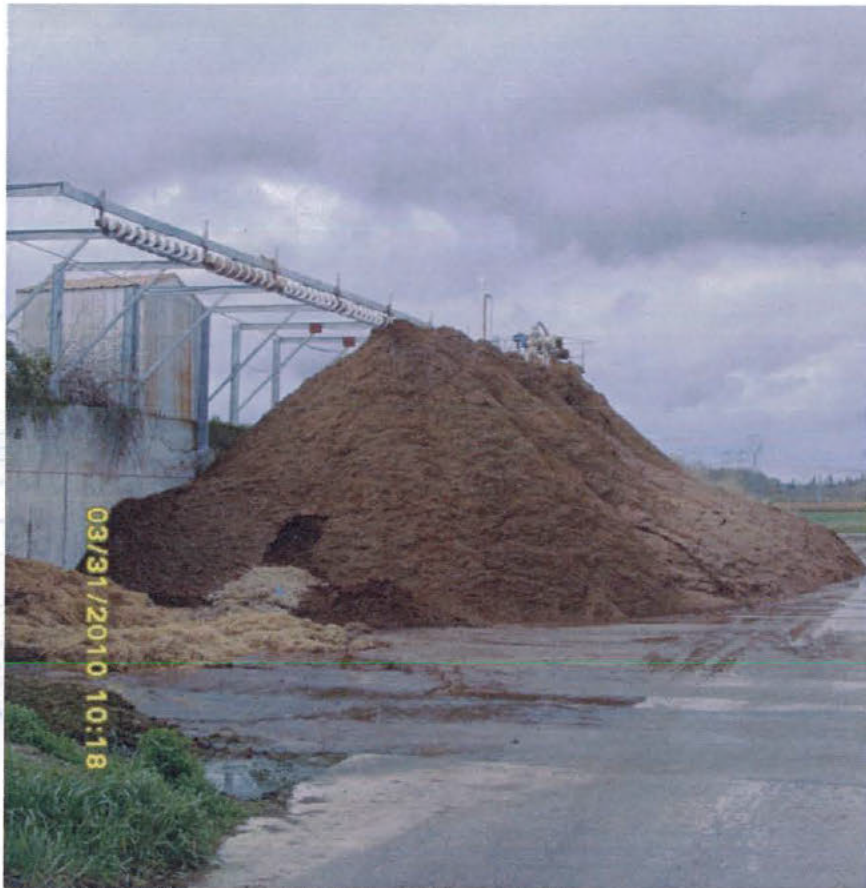
Photo 5. Solids separator.

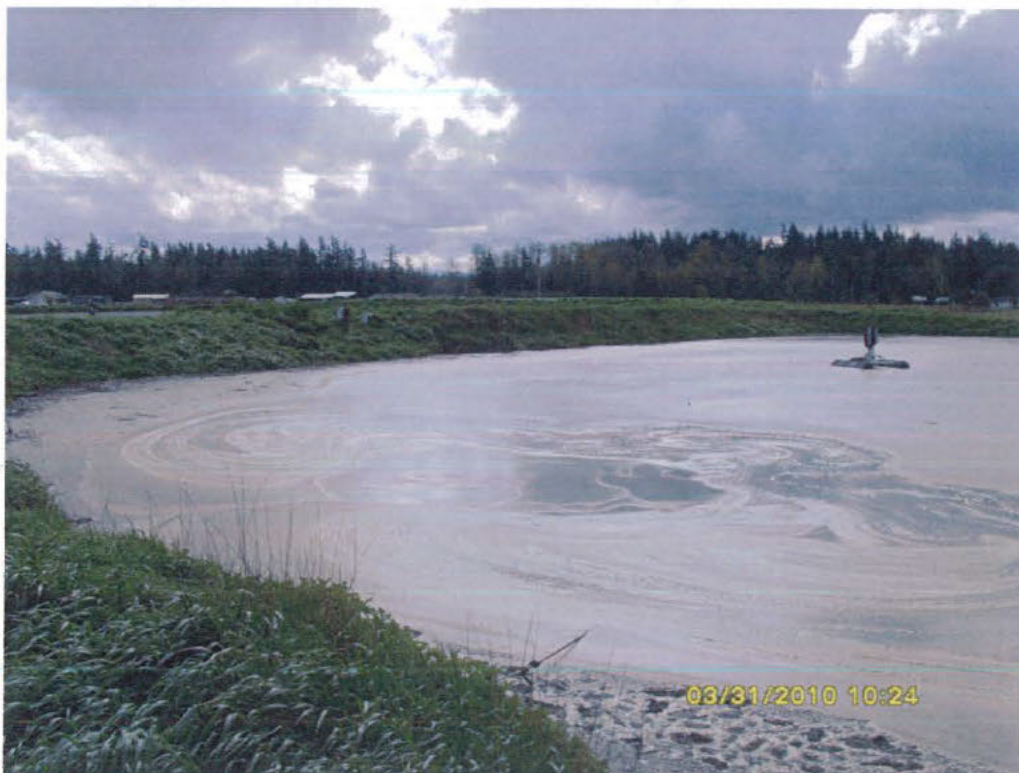
Photo 6. First liquid storage lagoon at the main dairy.

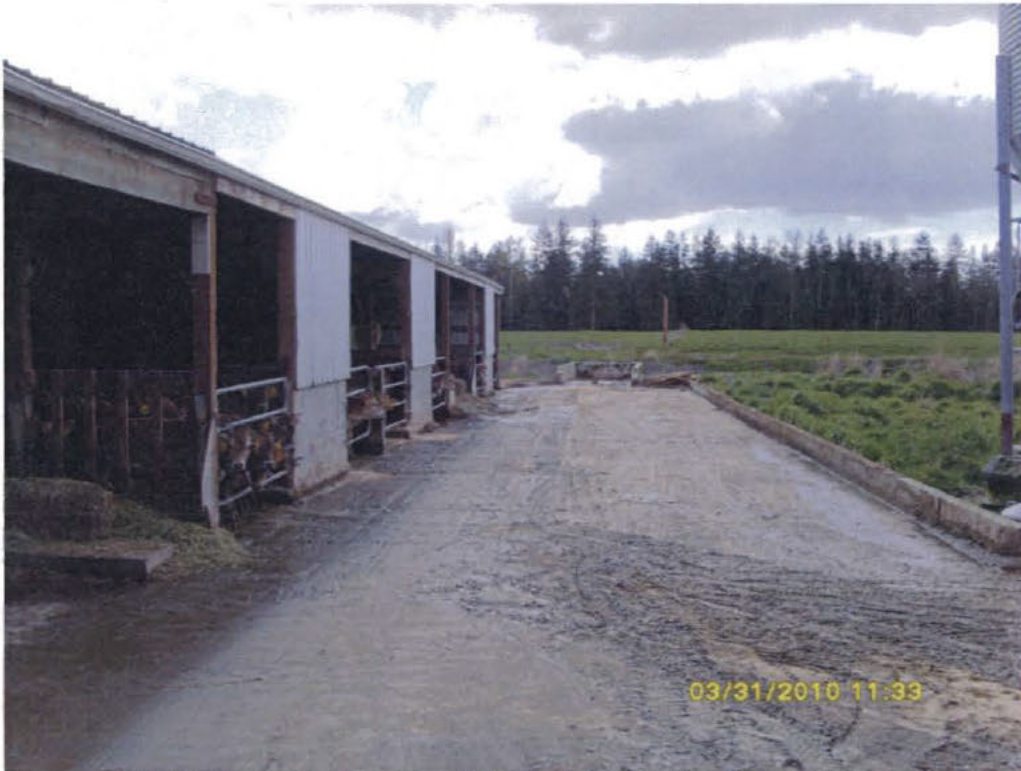
At the first heifer farm, waste is scraped with a tractor directly into the lagoon on a daily basis (photos 7 and 8). At the second heifer farm, waste is scraped daily into a pit and is then pumped into the lagoon (photo 9). Neither heifer farm has a solids separator. At the second heifer farm, stormwater from the roofs is normally routed into a ditch, but can be routed into the lagoon to dilute the waste to make it easier to pump out.

Photo 7. Area that is scraped into the lagoon at the first heifer farm.

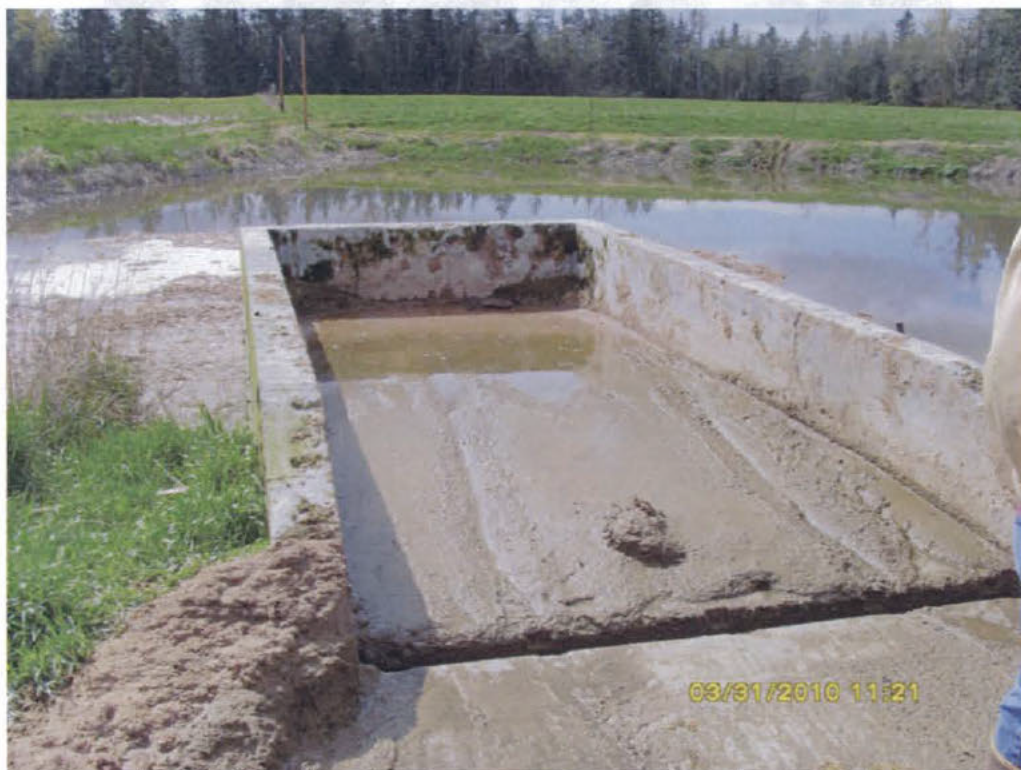
Photo 8. Lagoon at the first heifer farm with slot drain for scraping.

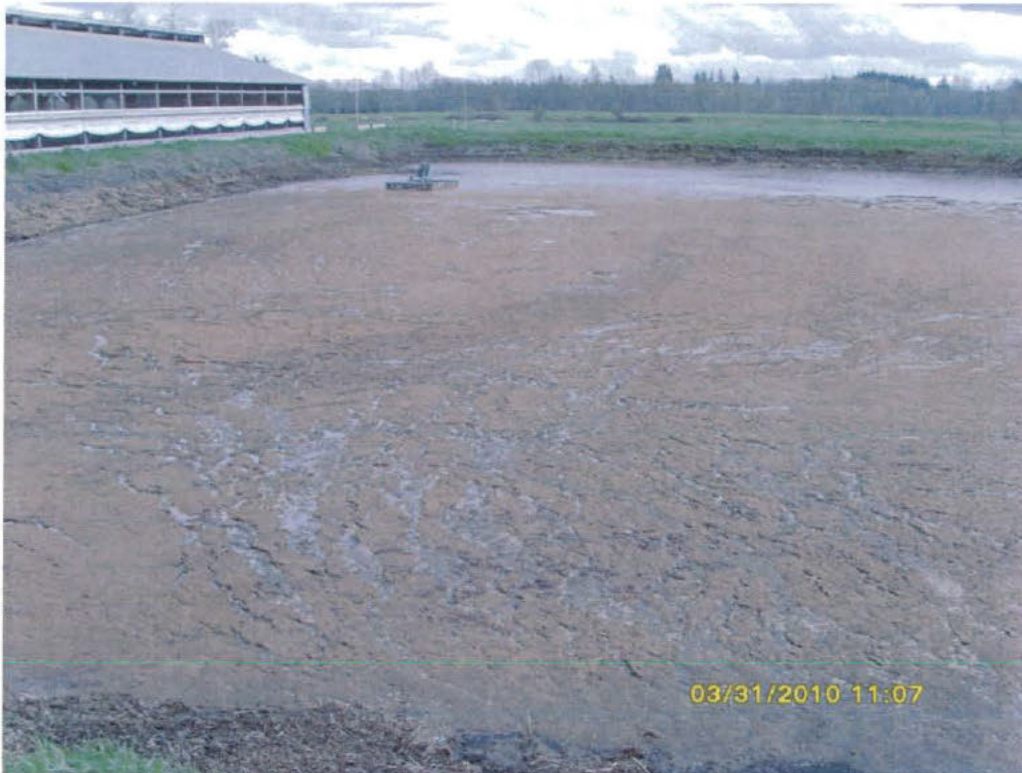
Photo 9. Waste storage lagoon at the second heifer farm.

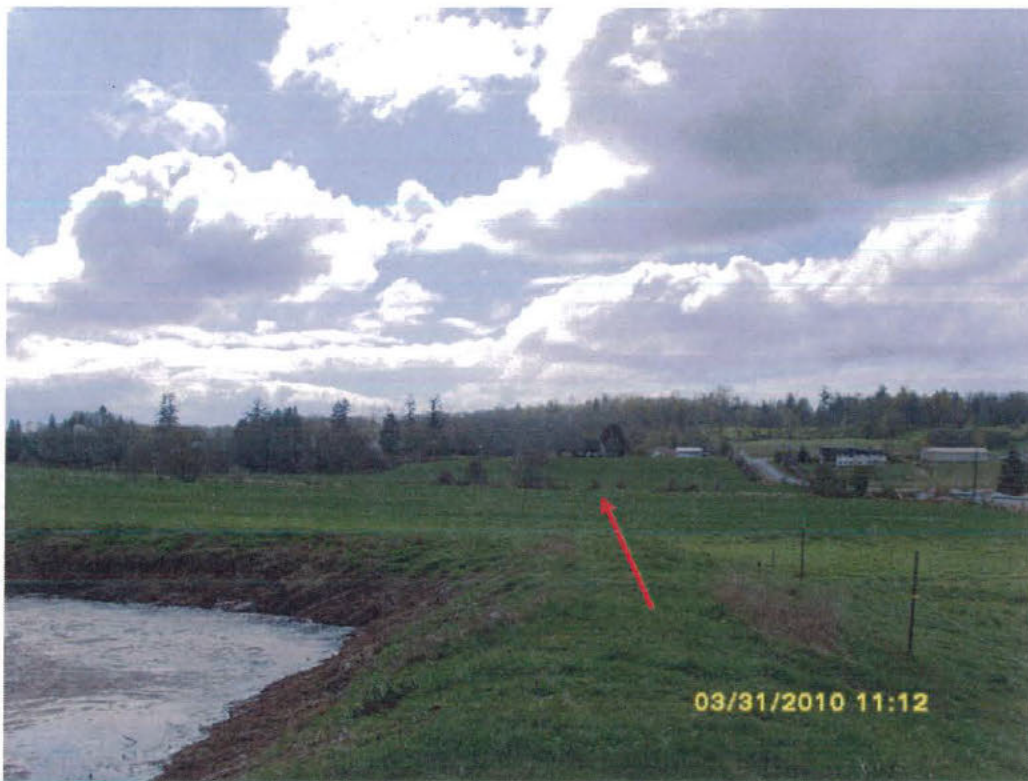
The nearest surface water is California Creek, which runs through Ed Pomeroy's field at the second heifer farm (photo 10). The creek eventually flows into Drayton Harbor in the Puget Sound. No surface water borders the main dairy or the first heifer farm.

Photo 10. Nearest surface water, California Creek (indicated with the arrow), to Ed Pomeroy's property at the second heifer farm.
